The Use of Computed Tomography and Ultrasonic Imaging for Assessment of Defects in Plates Made of a Polyesthetic Resin

Daniela Ioana TUDOR, Stefan Dan PASTRAMA, Anton HADAR

University Politehnica
Department of Strength of Materials
Faculty of Engineering and Management of Technological Systems
Splaiul Independentei 313, Sector 6, 060042, Bucharest, Romania
e-mail: stefan.pastrama@upb.ro

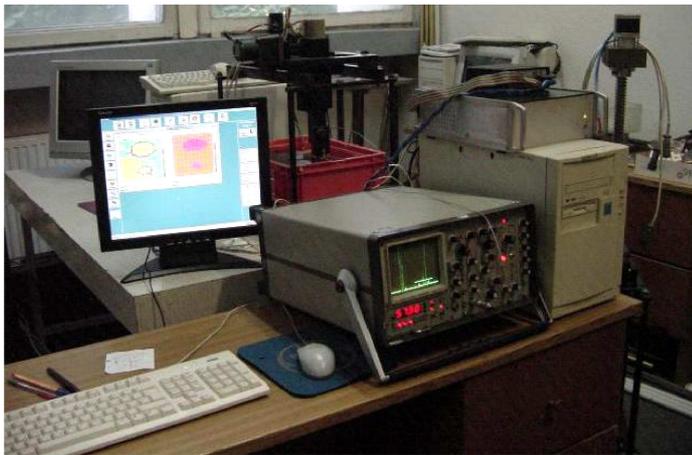
FIG. 5. The experimental set-up for ultrasonic imaging.

The second step of this research is the analysis of the studied plate using ultrasonic imaging. For this purpose, an equipment Nuclear MicroSonic-01 was used. The experimental set-up, shown in Fig. 5, is a complex equipment for automatic ultrasonic examination of rectangular or cylindrical samples in order to detect and characterize flaws in the analyzed structure [18]. The equipment allows ultrasonic examination with different incidence angles, both using longitudinal and transversal waves. The area under examination is automatically scanned with a high resolution ultrasonic fascicle, using mechanical devices for displacement and a data acquisition system for amplitude and flight time data, measured on the echo signals, synchronous with the scanning of the investigated domain. The obtained data, saved in amplitude and time of flight files depending on the used coordinates (circumferential or radial) allow construction of C-scan or B-scan ultrasonic images of the scanned area. From the pair of C-scan representation in amplitude and time of flight corresponding to each incident angle, a B-scan representation depth of defect – radial position can be achieved for a section through the sample. Such images are extremely useful since they contain all information regarding the found defects: shape, dimensions and orientation.
